3rd Row Seat May Not Fold Flat

Service

YEAR(S)	MODEL(S)	ADDITIONAL INFORMATION	
2012 – 2013	Highlander

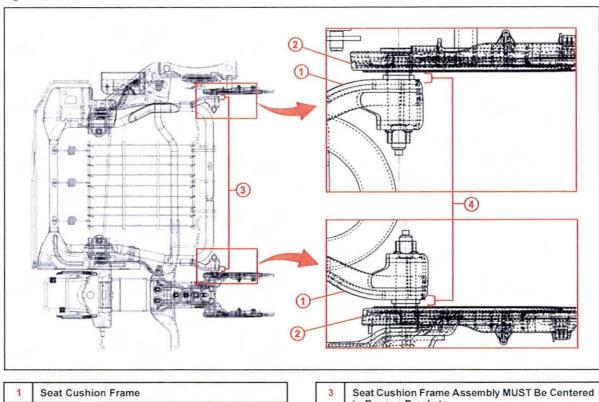
Figure 2.

Some 2012 – 2013 model year Highlander vehicles may exhibit difficulty when folding down or stowing the third row seat assembly due to binding between the seat frame and the banana bracket guide in the seat assembly. Follow the Repair Procedure in this bulletin to address this condition.

1	Seat Cushion Frame	3	Seat Cushion Frame Assembly MUST Be Centered	
2	2 Banana Bracket		in Banana Brackets	
		4	These Distances MUST Be Equal

During the installation of the lower seat cushion frame, it is imperative that the assembly is centered in the corresponding banana brackets.

- A. Loosen the seat cushion frame mounting bolts to allow for the seat cushion frame to be shifted.
- B. With the seat cushion frame mounting bolts loosened, shift the seat cushion frame to create an equal gap dimension between the seat frame and the banana brackets.
- C. When the equal gap dimension is achieved, torque the seat frame mounting bolts per the Repair Manual specifications.
- 3. Reassemble the vehicle in reverse order and confirm normal operation.
